## Walkability Report No 1

### Appendix A

#### Broadwalk to Bath Bridge

#### Feedback by volunteers on obstacles and benefits on the route

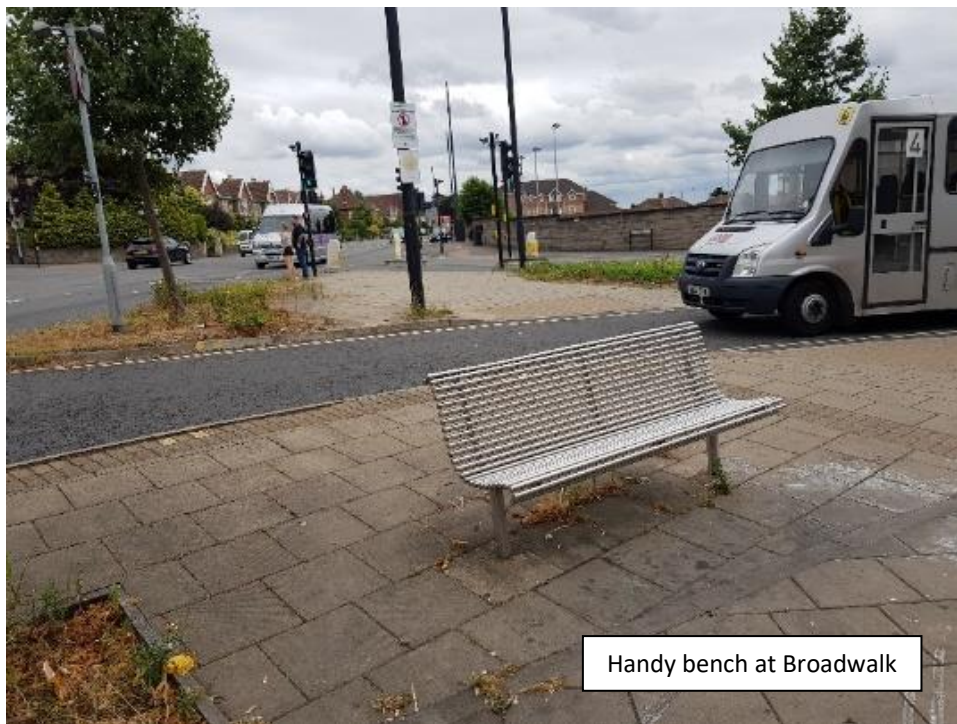
1. Broadwalk/Wells Road junction – Green Man indicator is given in every direction at the same time but there is insufficient time for the pedestrian to comfortably cross in any direction (ie diagonally); therefore, to cross the road diagonally, it is necessary to cross the feeder roads in turn waiting for a cycle of the traffic lights at each stage
2. Bench by the Broadwalk Shopping Centre

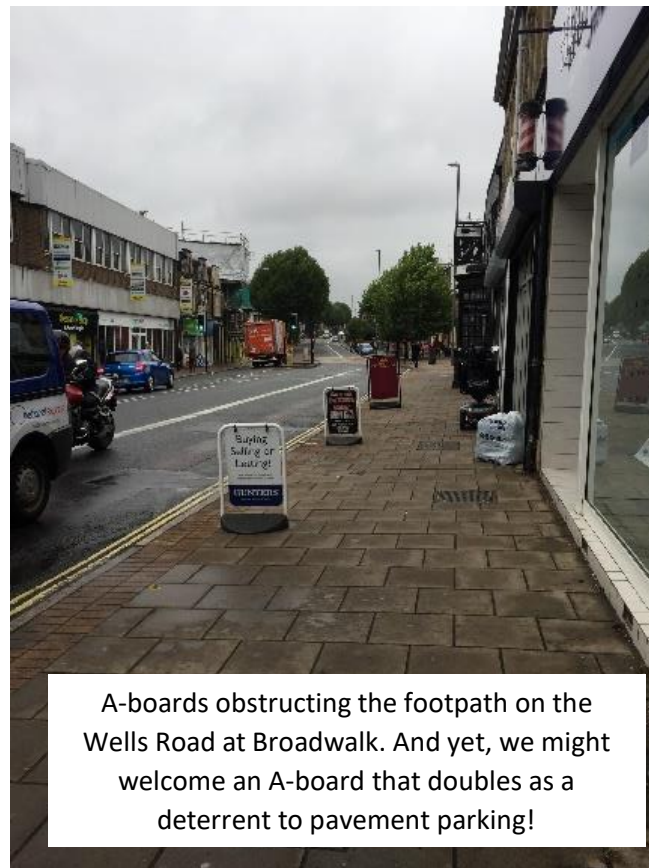
5. Presence of A-boards on the pathway resulting in needless obstruction

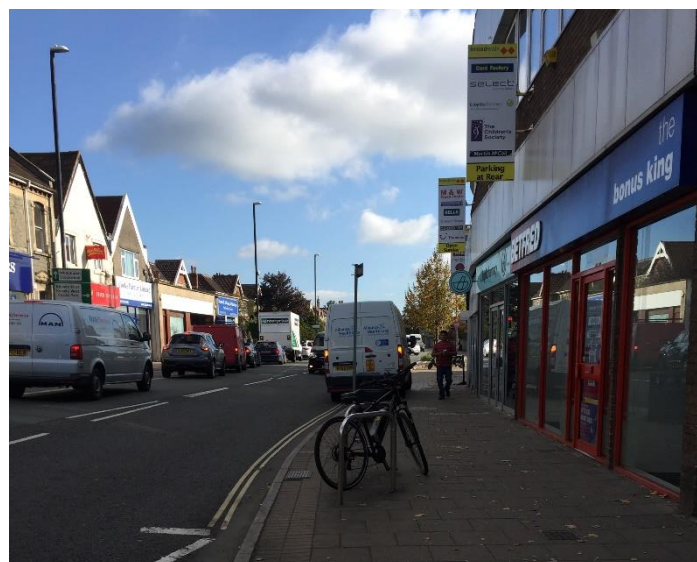
6. Sheffield stands for bicycles positioned at an angle on the pavement resulting in needless pavement narrowing

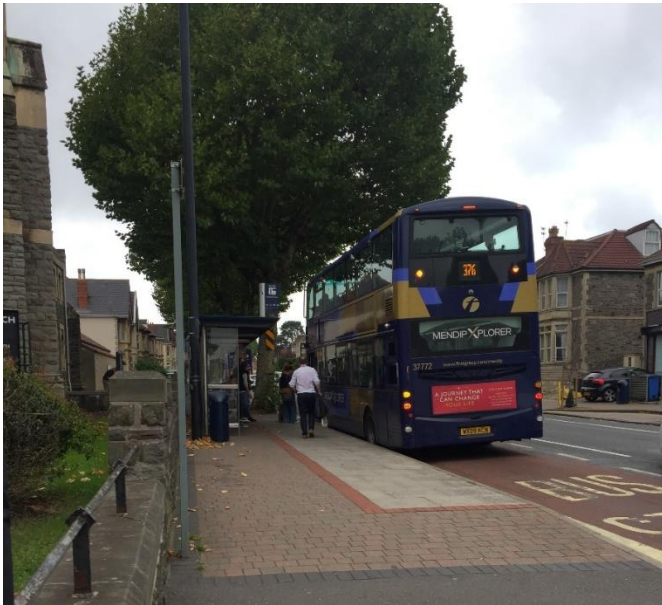
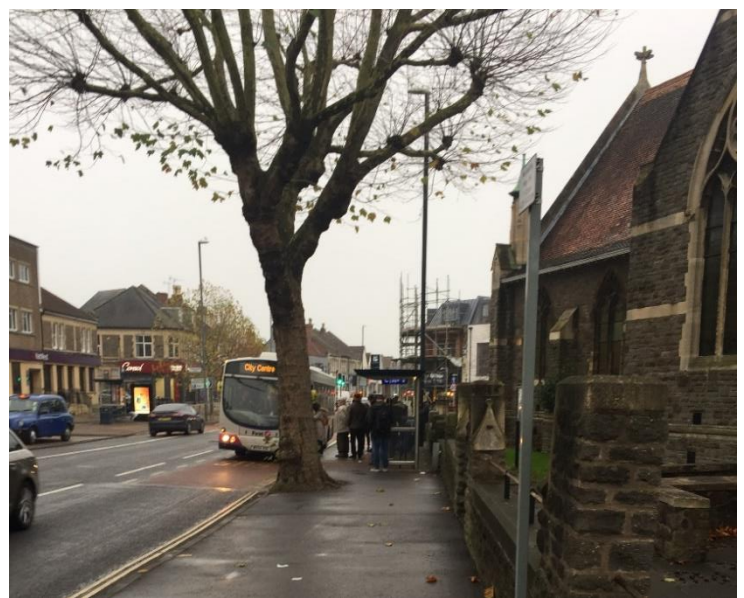
7. Bus stop and shelter taking up the full width of the footpath when busy with people queueing and boarding an in-bound bus

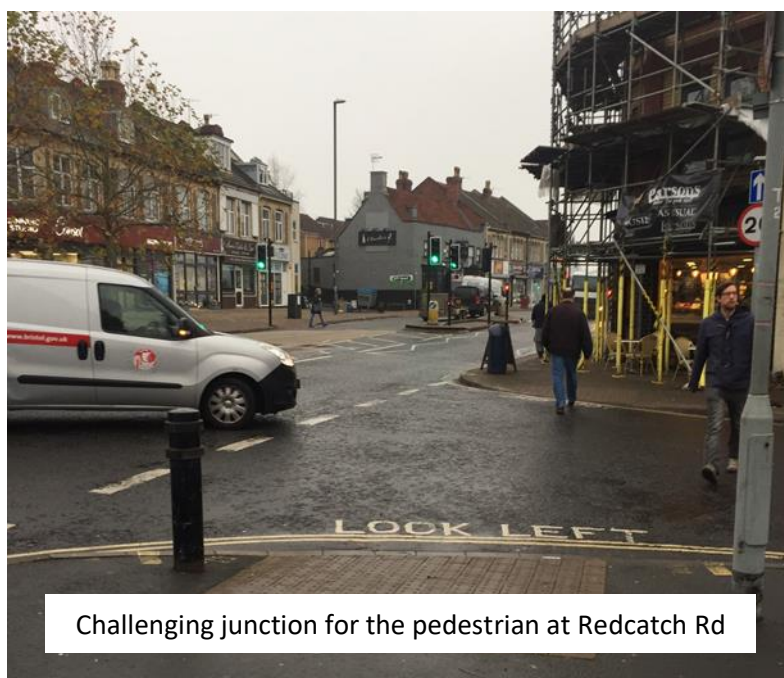
- Redcatch Road – vehicles turn at speed off the Wells Road into Redcatch Road (a one-way street) – this means that the pedestrian crossing Redcatch Road must look out for vehicles turning off the main road suddenly from north and south directions

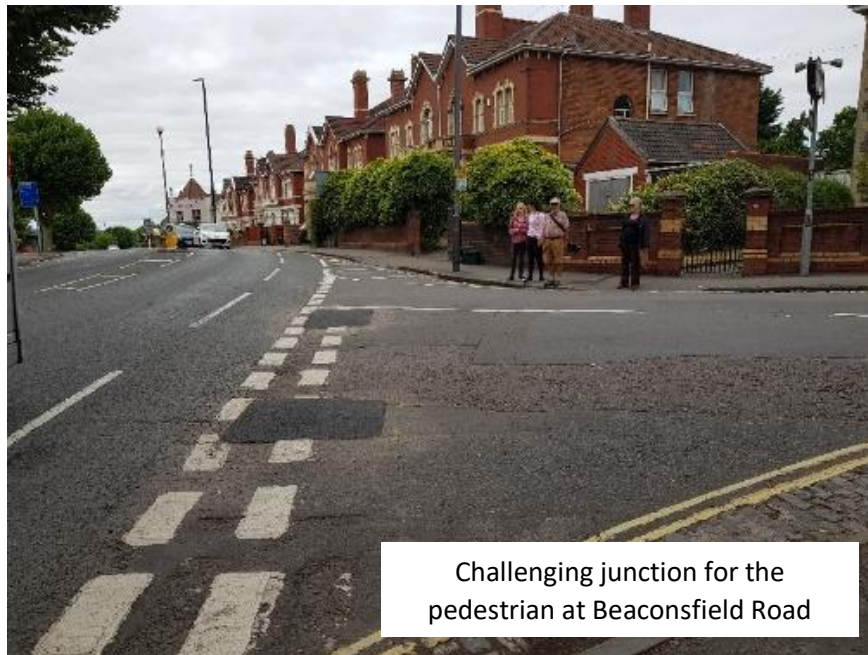
- Beaconsfield Road – very wide side road with fast traffic leaving the main road from 30mph to 20 mph zone – the curved pavement encourages the driver to maintain main road speed into the side road

9. Where a traffic island is provided to support crossing the Wells Road between junctions with Beaconsfield and Calcott Roads, we found the central island too small and felt vulnerable with traffic travelling at speed on both sides – you can see this informal crossing on the left of the above photograph indicated by a tall pole carrying a spherical lamp

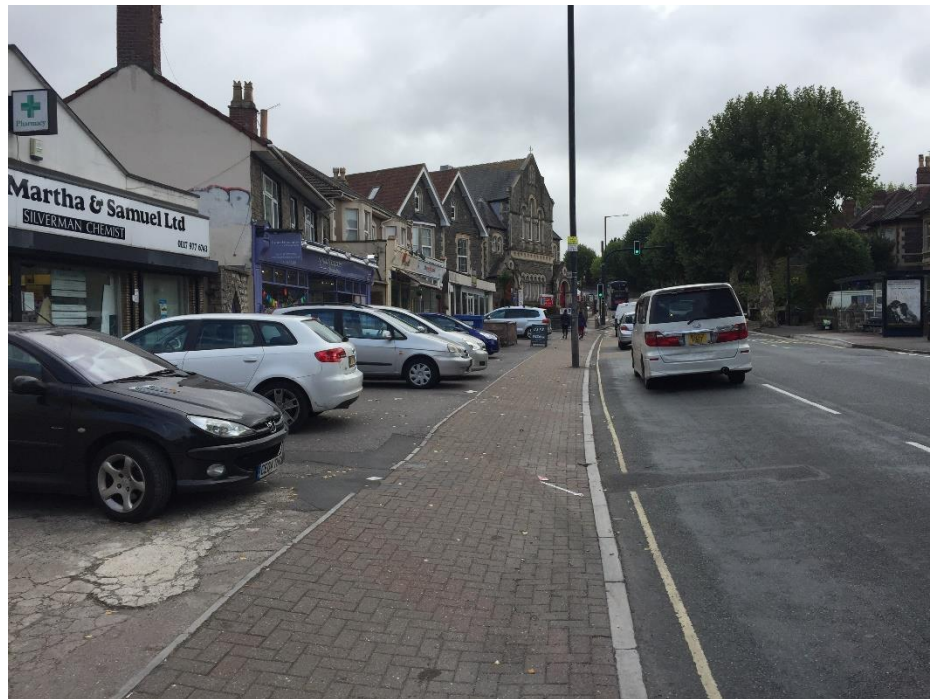
14. Damaged brick-paved footpath fronting parade of shops (Wells Road Nos. 180 to 186), used by cars to pass over to park, making it a precarious place to walk – pavement rough and sloping towards the roadway

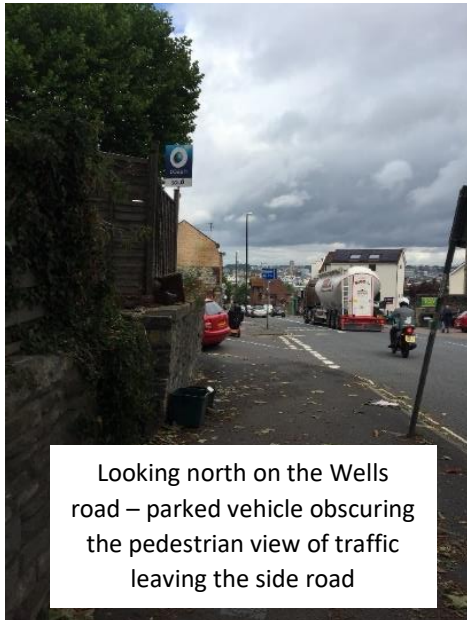
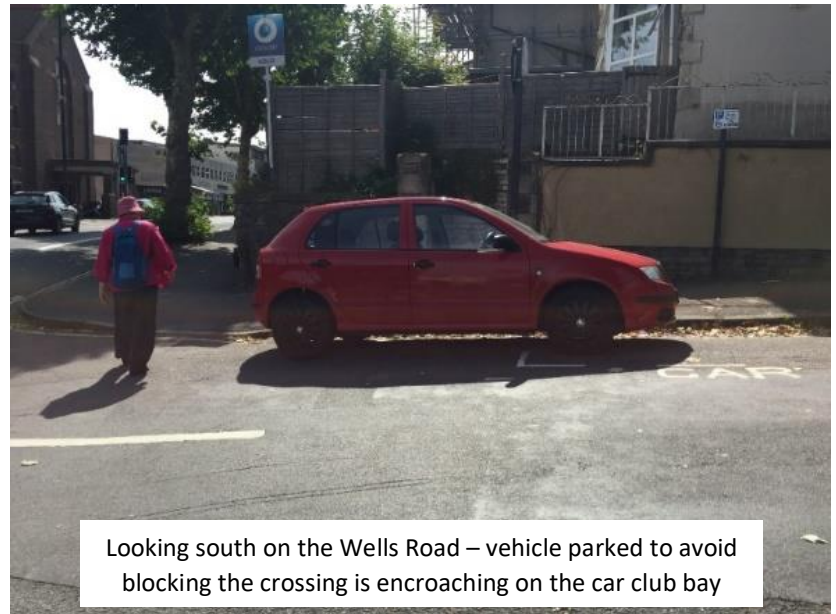
- Lilymead Avenue – the side road slopes onto the main road and as a result a vehicle speeds up leaving and joining the main road; this junction also has a kerb space between the dropped kerb and the City Car Club reserved parking bay which is not quite big enough for a vehicle but, if parked regardless, results in an obstruction for the pedestrian crossing the side road

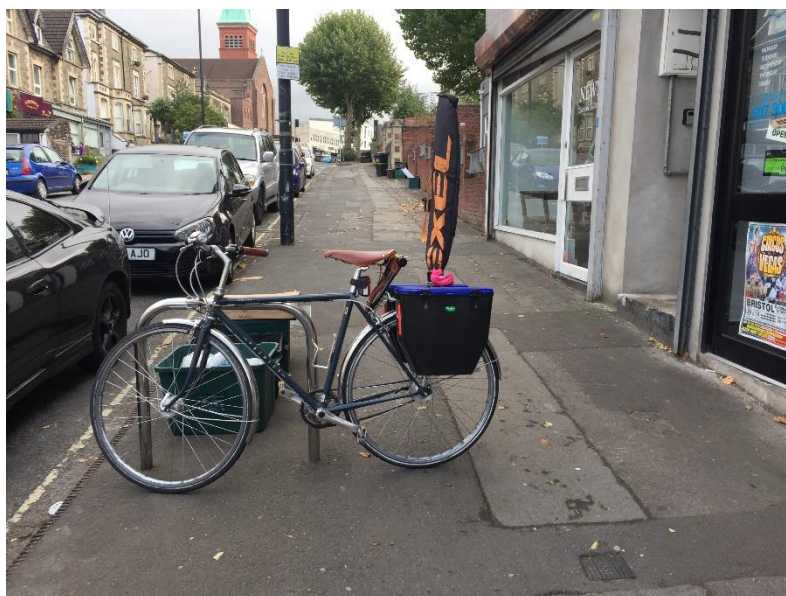
20. Sheffield stand for bicycles positioned at an angle on the pavement resulting in needless narrowing – if this Sheffield rack were parallel to the main road it would double as a bollard to prevent pavement parking

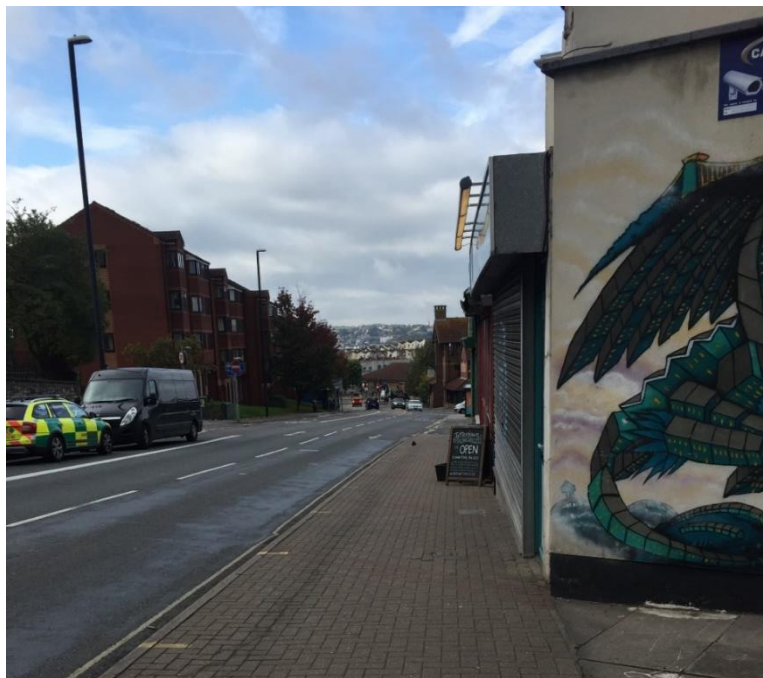
21. Footpath close to fast and noisy traffic passing this parade of shops (inc. 142 Wells Road), due to narrowing of the road and cars (legally) parked in the bus lane opposite

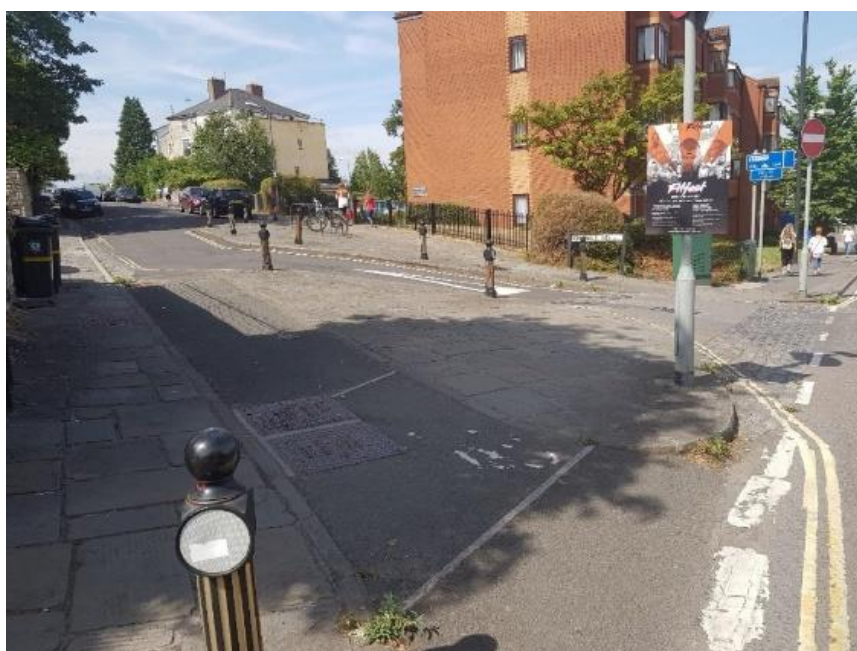
22. Continuous pavement over the one-way junction with Knowle Road is a good experience for the pedestrian but would benefit from a traffic stop line on the Knowle Road side of the continuous pavement

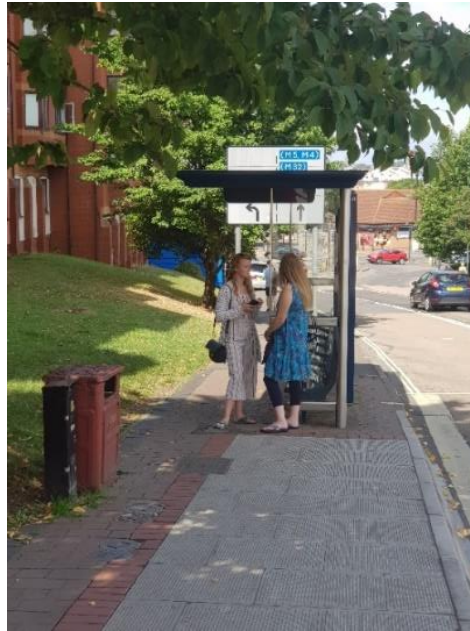
23. Continuous pavement at Knowle Road incorporates a cycle path which is not obvious to the pedestrian and laid out to suggest that the pedestrian should give way
24. Bus stop and shelter taking up the full width of the footpath when busy with people queueing and boarding an in-bound bus

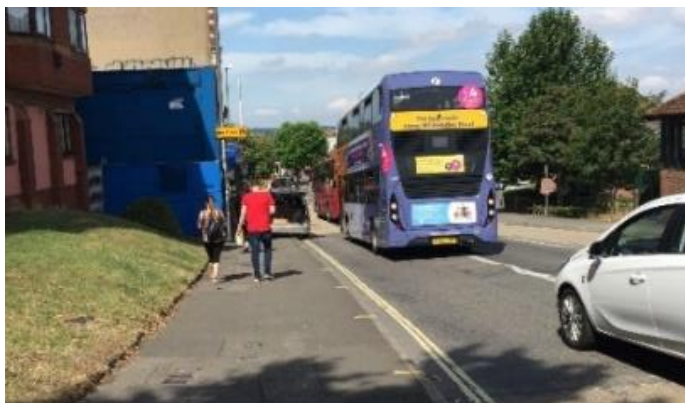
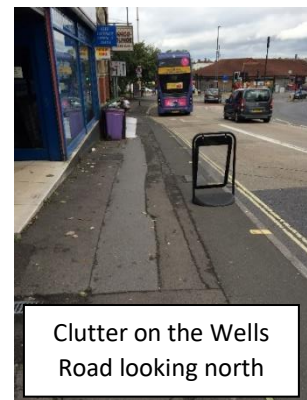
Clutter on the Wells Road looking north

25. Stores on the west side of Wells Road, south of the St Johns Lane junction – vehicle parked on the pavement, obstructing inward bus flow, driver unloading goods into the store; on examination we could find no other access to the store for deliveries; it appears that the store no longer has its former delivery entrance at the rear – presents a dilemma: encouraging local shops / creating safe pavements

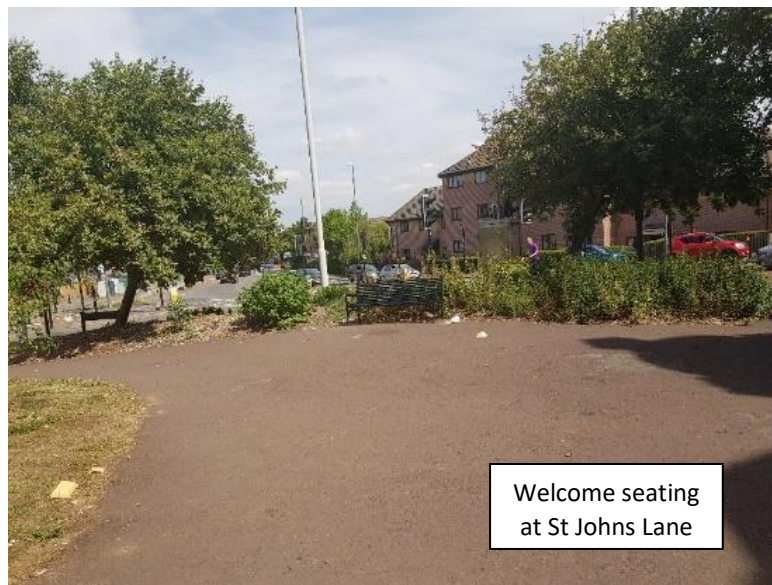
27. Nice place to rest at the Wells Road junction with St Johns Lane, thanks to the efforts of local campaigners, much appreciated

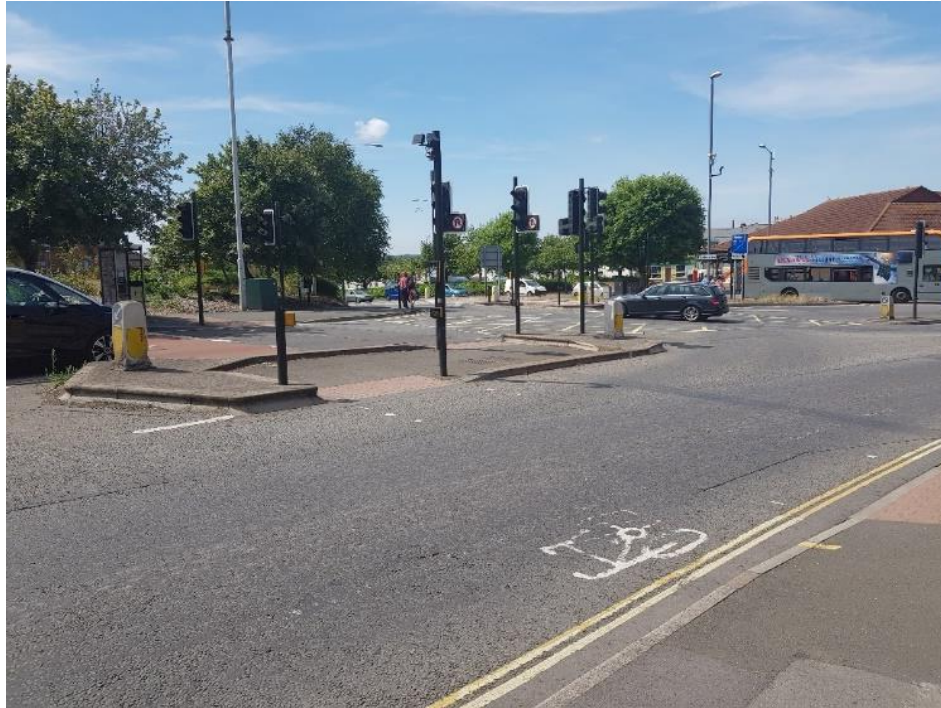
28. Up to five stages to crossing at the Wells Road/St Johns Lane junction; encourages the pedestrian to dash through the traffic

St Johns Lane/Wells Road if you want to get from Mama Bear's Day Nursery (on the east side) to Tesco (on the west side) you must first cross the southbound Wells Road traffic, then the northbound traffic, walk a bit cross the westbound St John's Lane traffic, cross the eastbound St John's Lane traffic turning south, then finally the eastbound St John's Lane traffic going north on the slip road. Nimble pedestrians follow the shortest route by running through the traffic!

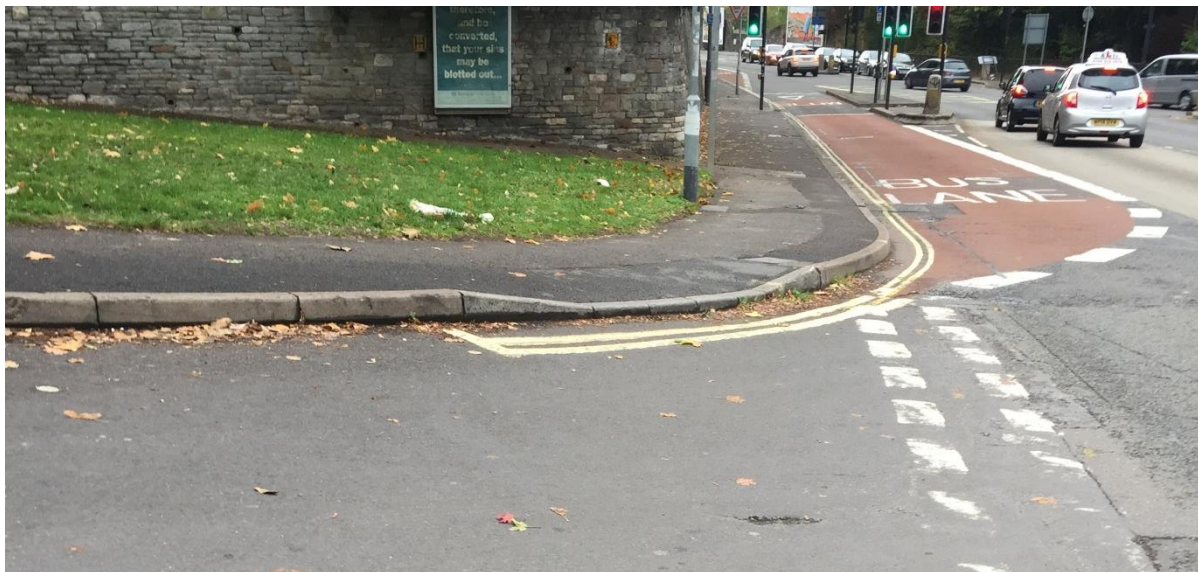
32. Drop kerb at Bellevue Road in need of improvement – drop kerb insufficient

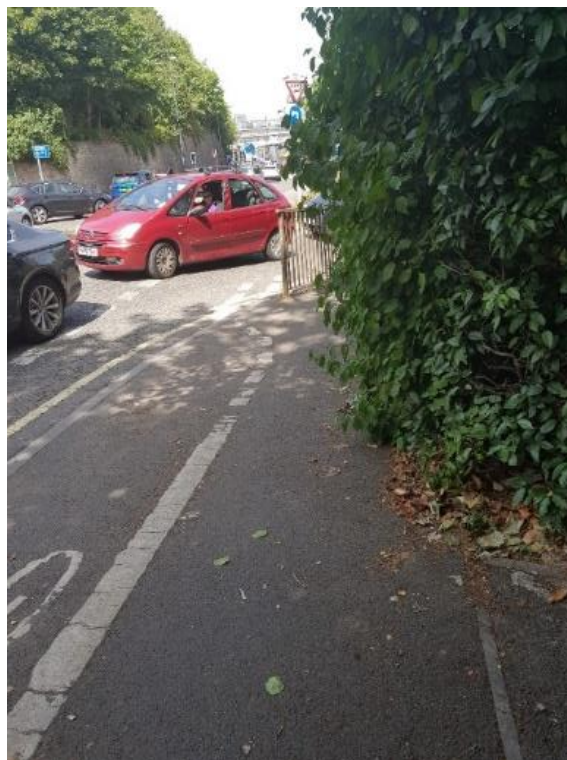
33. Wells Road east side - overgrown trees obstructing and obscuring the footpath on the approach to the Bath Road at Three Lamps junction

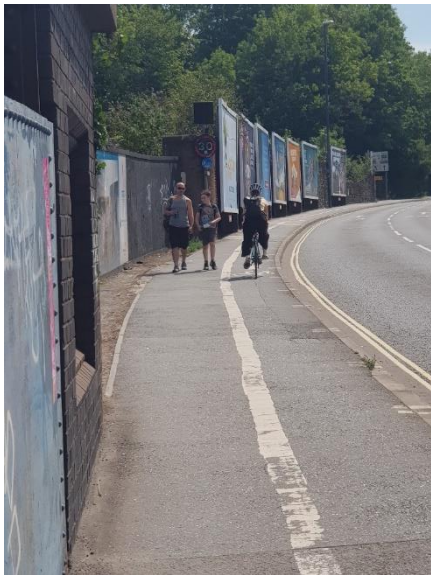
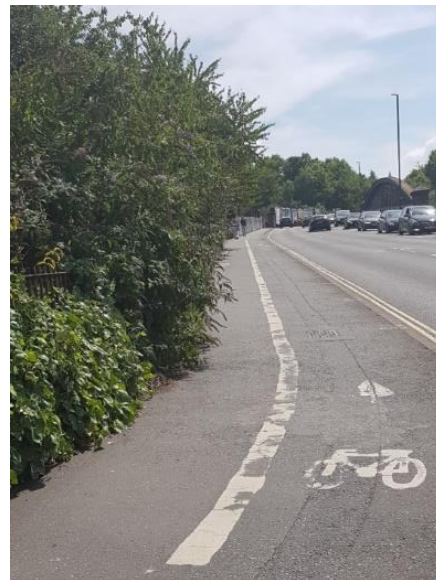
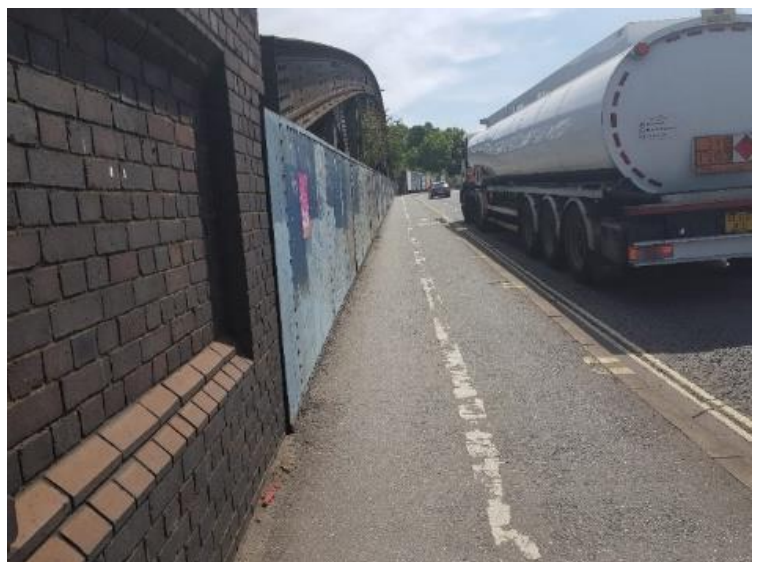
36. Bath Road east side –this is a very narrow path with a white line down the centre to segregate the pedestrian from the bicycle user; cycle path is outbound only (going south) but frequently used inbound and can be frightening for all users

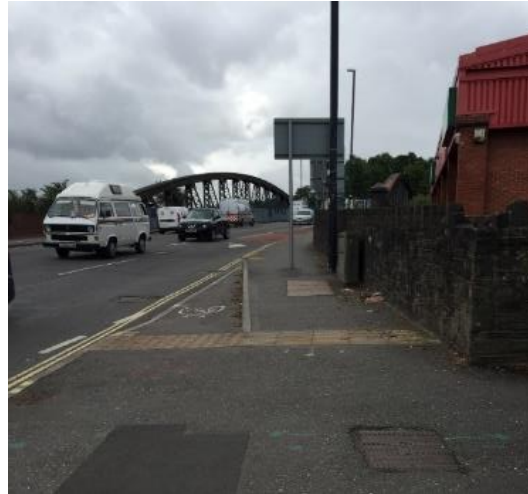
37. Bath Road west side approaching Bath Bridge – bicycle-user slip road from highway onto footpath with no indication to pedestrian or cyclist how to deal with this

38. Bath Road west side – road sign posts in the roadway at the cycle slip road, pictured above, create an obstruction: space between the posts is 88cm and between the right-hand post and the kerb is 110cm

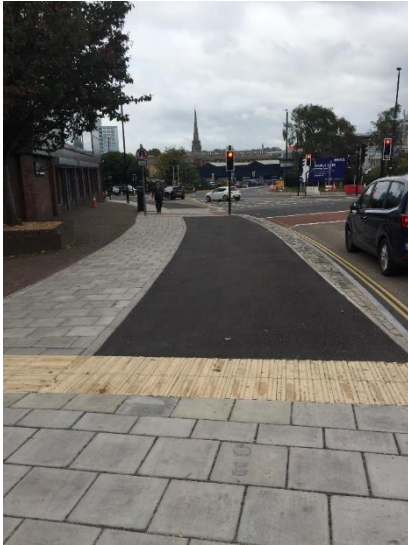
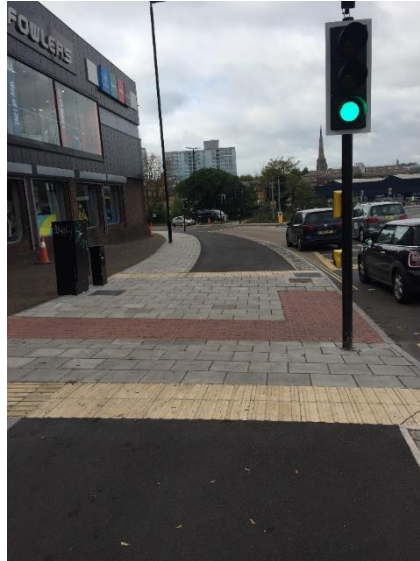
39. Newly refurbished section of road and footpath at the approach to the Bath Bridge – not clear why half the pavement is tar and rest is paving stones – potential for huge pedestrian/bicycle-user conflict
