### Plan of the Southern Half of Site Showing Major Features

# Plan of the Northern Half of Site Showing Major Features

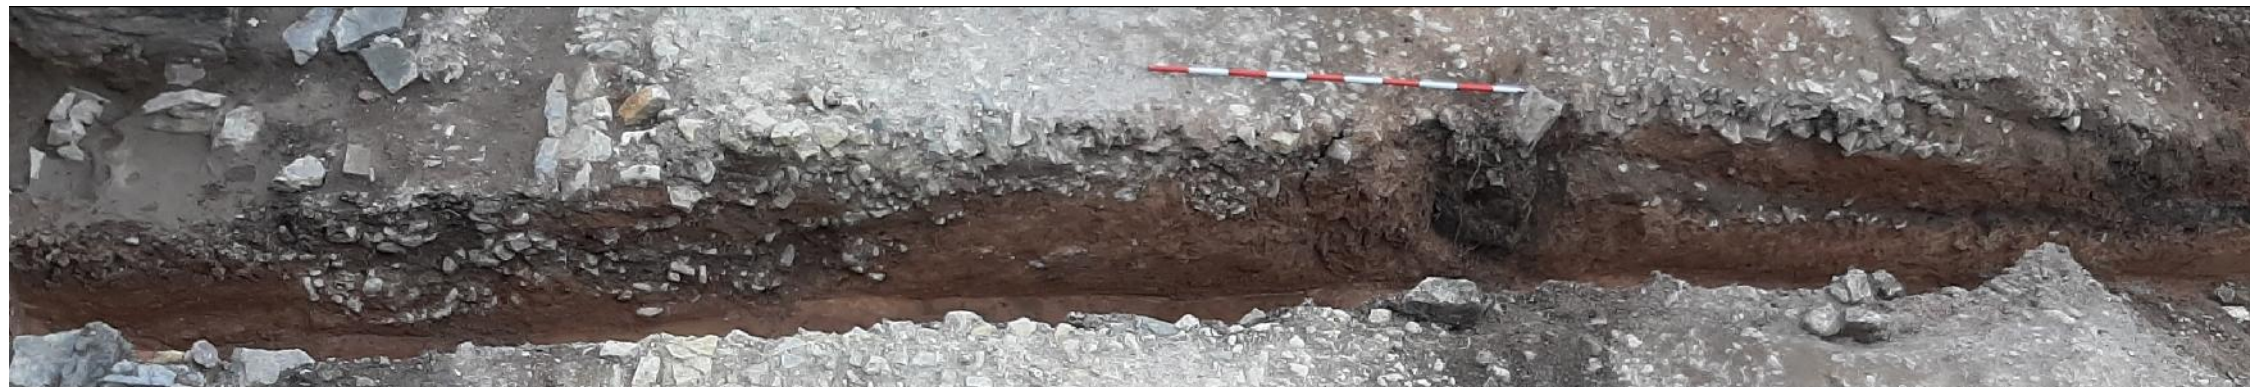
Figure 8

Plate 6: Section 1. East facing. 1 x 2m scale

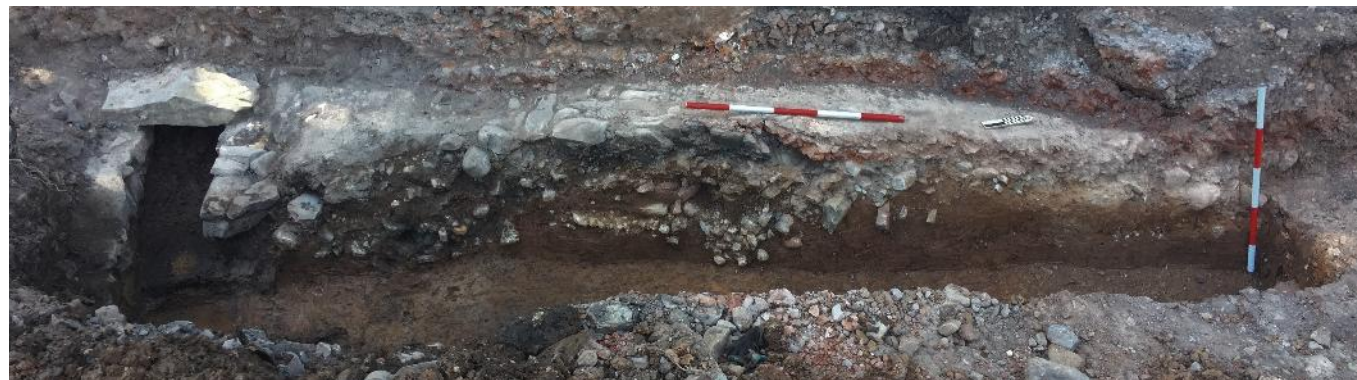
## Section 2

Plate 7: Section 2. East facing. 2 x 1m scales

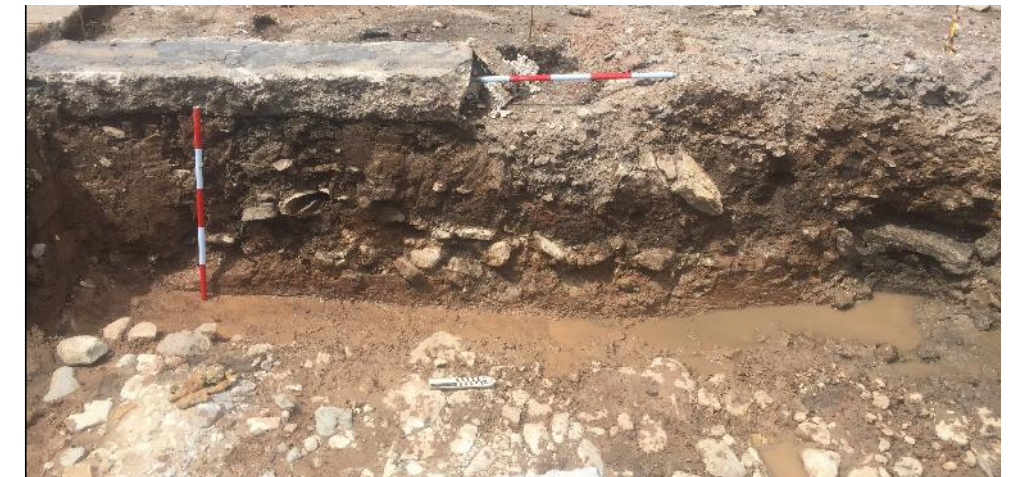
### Figure 9

Plate 8: Section 3. East facing. 2 x 1m scales

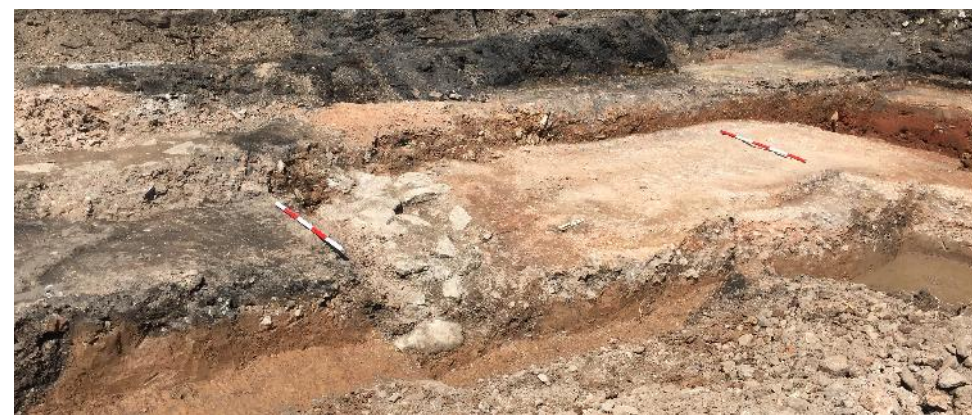
### Section 4

Plate 9: Looking north-west at section 4. 2 x 1m scales

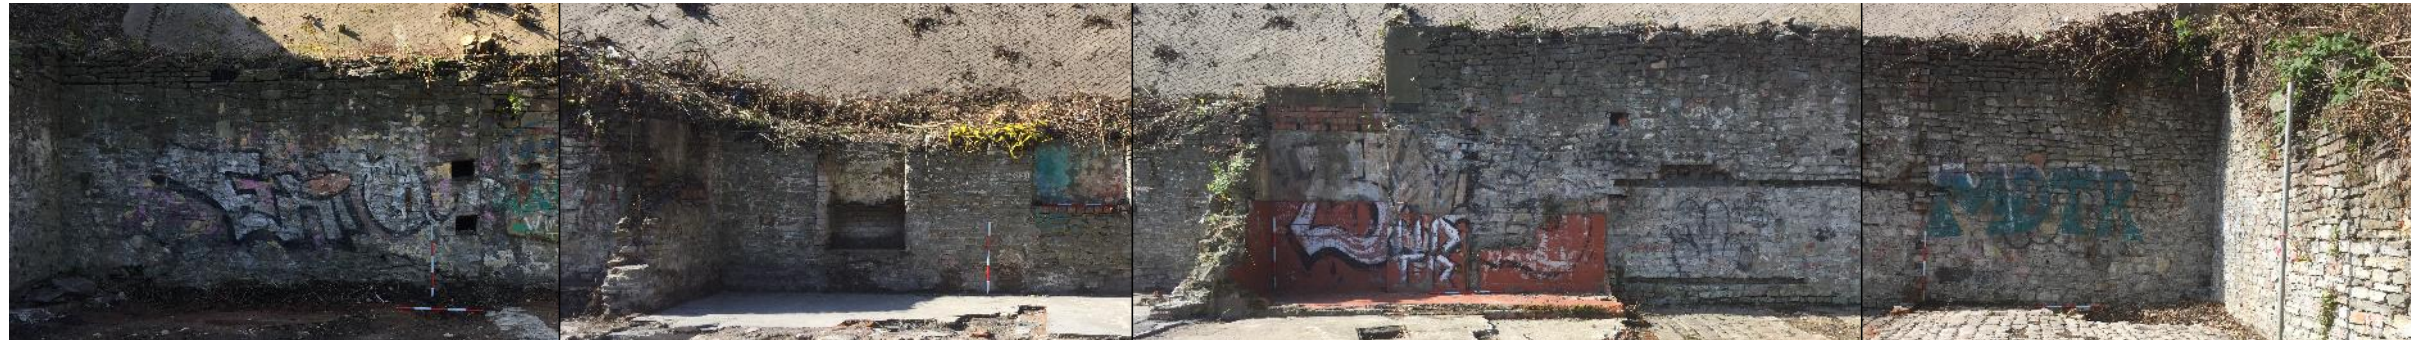
## Elevation 1

Plate 10: Composite Photograph of Elevation 1. Approximate Scale

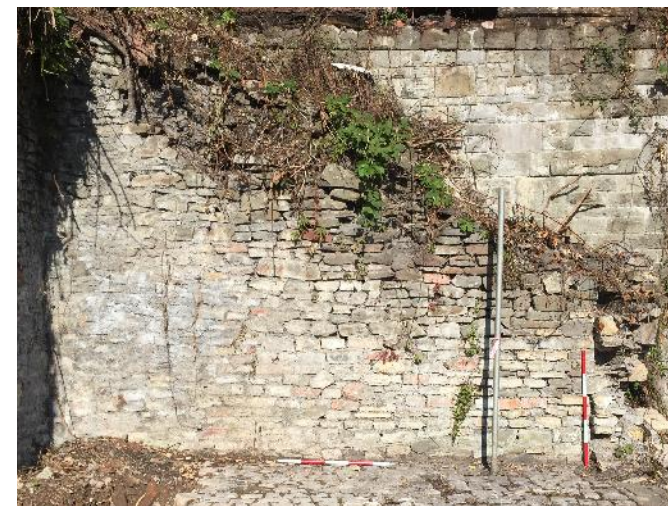
## Elevation 2

Plate 11: Elevation 2. 2 x 2m scales

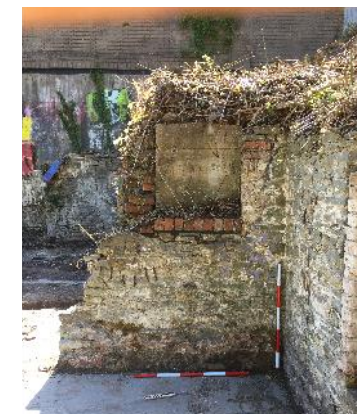
## Elevation 3

Plate 12: Elevation 3. Approximate Scale

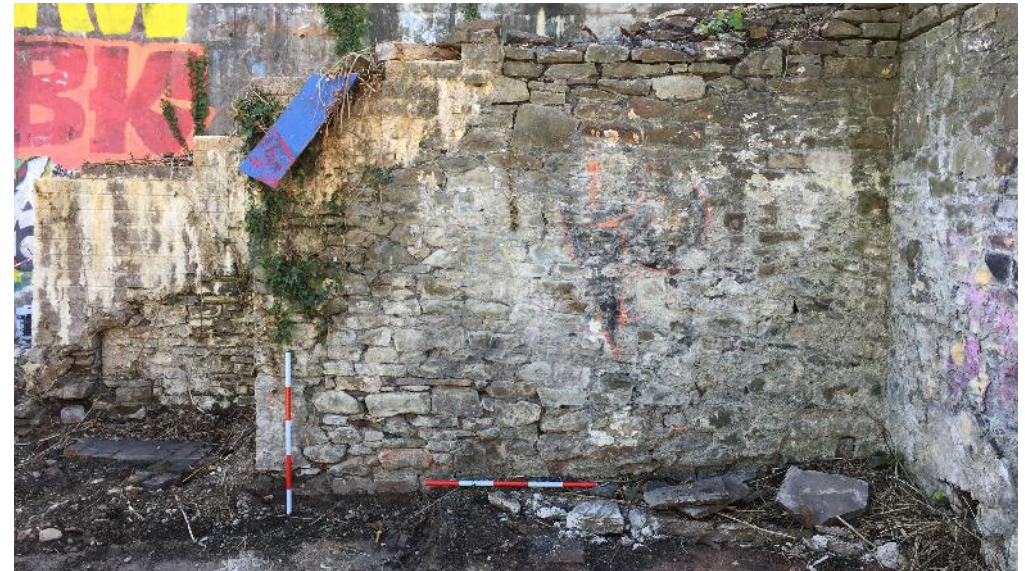
## Elevation 4

Plate 13: Elevation 4. 2 x 2m scales

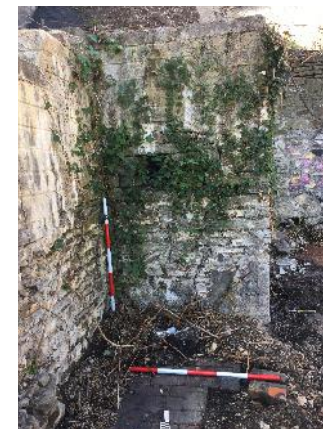
## Elevation 5

Plate 14: Elevation 5. 2 x 2m scales

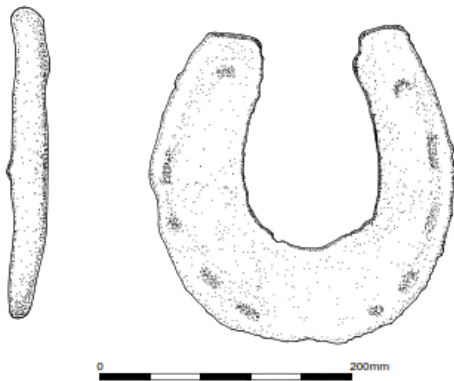
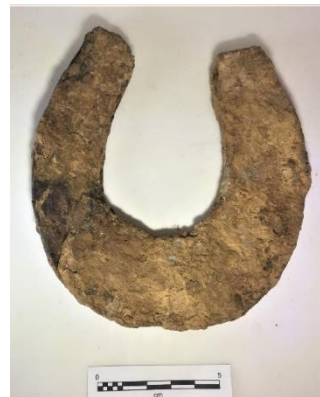
Figure 14/Plate 18:  
'Tongue' horseshoe  
from context 1092.

The complete horseshoe from context 1092 appears to be a 'tongue' horseshoe (1680-1820), of a size consistent with those for draught horses (Sparkes, 1976, 20). The possible lack of a fuller (a groove through which nail holes are punched) suggests it may be an earlier example. The possible partial horseshoe from the same context is heavily corroded but has what appears to be a broken nail in situ, with a second nail hole nearby. Not enough remains to identify its type. Two heavily concreted fragments appear to form a near-complete shoe; however typological identification was not possible.

| Context | Count | Weight (g) | Material | Description |
|---|---|---|---|---|
| 1092 | 1 | 296 (approx. 10 ½ oz.) | Fe | 1 complete horse shoe, post-medieval. The horseshoe is U-shaped, with the branches being thicker and tapering towards the heel. The heel-end of the branches are squared, but with no evidence of calkins. Slightly convex on under-surface, and concave on the upper surface. There appear to be 5 nail holes on one branch (at least one with a fragment of nail protruding from upper surface); the other branch is more corroded with only 2 possible nail holes visible. Considerable iron corrosion product across the entire surface of the object – there does not appear to be a fuller but it may be obscured. Measures 127.4mm in length, 120.2mm in width (5" x 4¾"), thickness 8.5mm. |

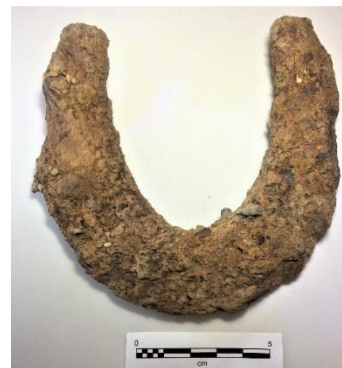
Figure 15/Plate  
19: Clark 'Type 4'  
horseshoe from  
context 1124.

The horseshoe from context 1124 is very similar in shape to that of Clark's Type 4 (as described and depicted by Webley, 2020), dating from the 14<sup>th</sup> to 16<sup>th</sup> centuries (ibid.), possibly into the 17<sup>th</sup> century (Sparkes, 1976, 14). It shows the distinctively angular inner profile at the toe end (Webley 2020); although the point is not so marked as in some examples, suggesting it may be from the later end of the period (Sparkes, 1976, 14). While slightly larger than the characteristic measurements, its size and weight are closest to those of a saddle shoe (ibid., 5).

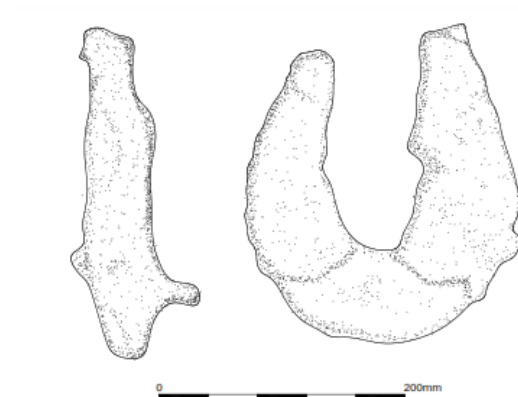
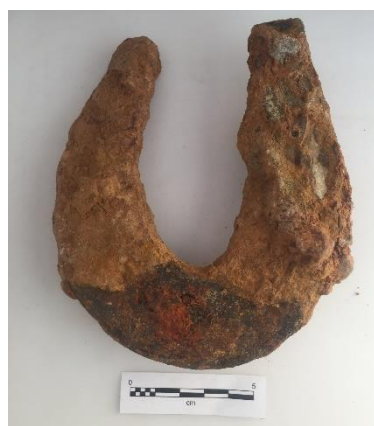
Figure 16/Plate  
20: Clark 'Type  
4' horseshoe  
from context  
1142.

The horseshoe from context 1143 is also similar in shape to Clark's Type 4 (Webley, 2020). It shows the same angular inner profile at the toe end, though narrower than the above, and has a possible single calkin. A broken nail is in situ, though no nail holes are visible on the branches due to concretions. The toe is free of concretion, and has no nail holes, suggesting it dates to no later than the 17<sup>th</sup> century (ibid.). The shoe is of a similar size to the horseshoes described above, but is considerably heavier (although also more heavily concreted). The weight, though exaggerated due to the concretions, is suggestive of a shoe for a draught animal (Sparkes, 1976, 13).

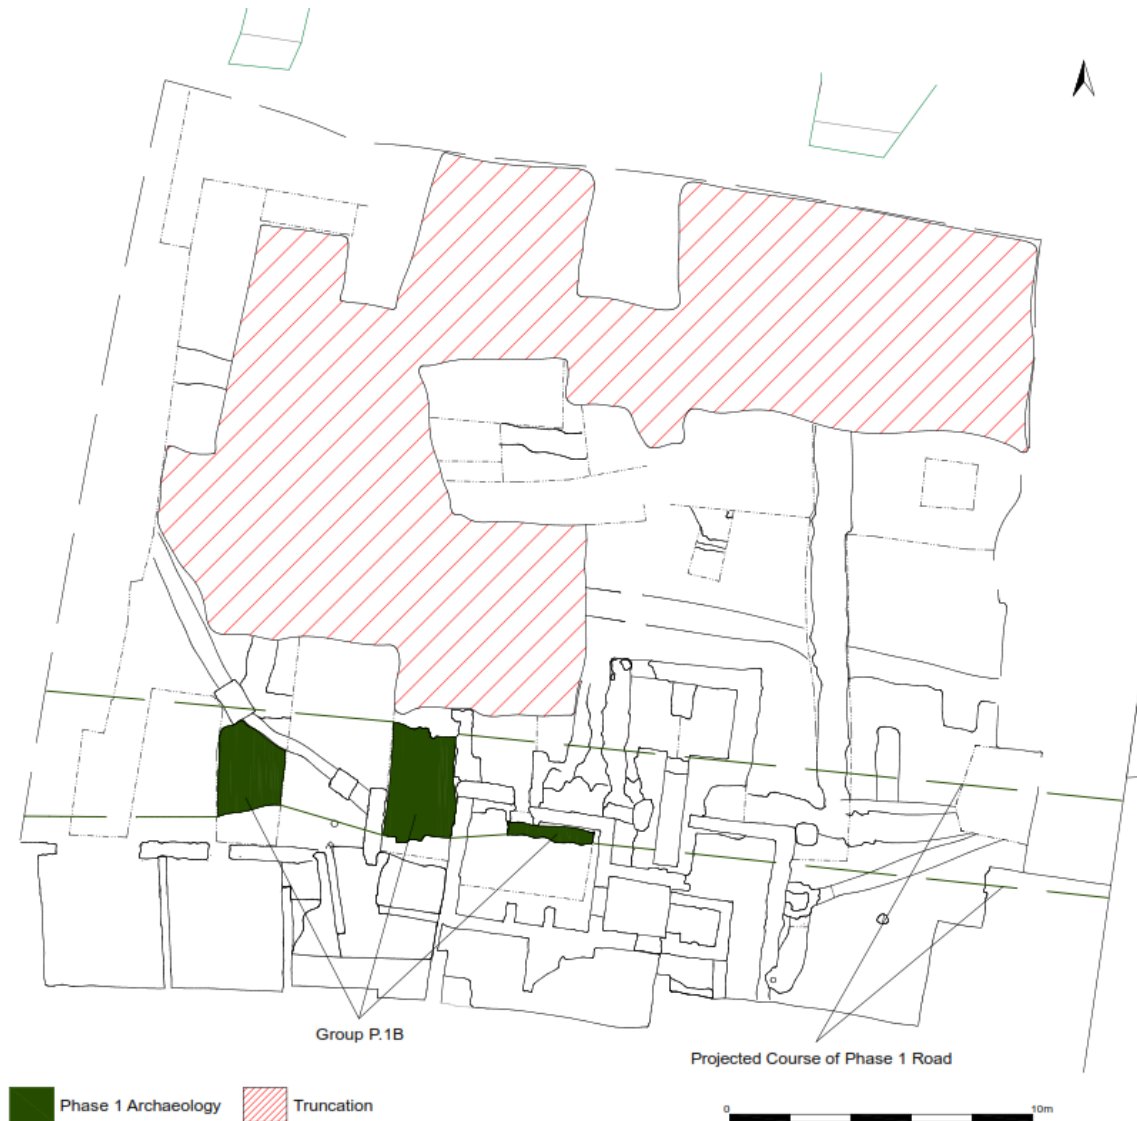
Figure 17: Plan of the site showing Phase 1 archaeology and the projected course of the road.

The earliest archaeology identified during the excavation was a possible buried soil (context 1143), which contained sherds of pottery dating to between 13<sup>th</sup> and 15<sup>th</sup> century. The relationship between this deposit and the stone spreads of Group 1A is unclear, although typological assessment of pottery and horseshoes recovered from form deposits 1092 and 1124 suggests a likely usage date of between the 17<sup>th</sup> and early 18<sup>th</sup> centuries, although it may have potentially have origins earlier than this. These spreads almost certainly derive from dumps of material to create an east to west aligned road surface running parallel with the southern bank of the River Avon. The road has relatively deep foundations (approximately 0.35m – 0.4m thick) which have either been deposited into an irregular linear cut or compressed into the underlying natural clay (context 1093). There does not appear to have been any formal sorting of the stone in the construction of the road, and the surface as exposed was uneven, although it is unclear if the upper layers have been truncated. The presence of glass and iron slag within the road makeup is unsurprising as these sorts of materials were frequently used in road construction during the post-medieval period. The deeper section of road on its northern side, seen on section 3, may reflect the earliest iteration of this road which was widened to the south at a later date.

Group 1A was overlain by another series of stone spreads comprising the deposits of Group 1B. Like group 1A these deposits form an east to west aligned road surface. No dating evidence from this road was found during the excavation; however, its stratigraphic position suggests a range of between 16<sup>th</sup> and the early 18<sup>th</sup> century. The most complete section through this road group was excavated to the east of site. The road surface was composed of unsorted stones, of a maximum of 16mm, with an uneven surface and a width of approximately 3.6m. The northern edge of the road suggests it was cambered, although the southern side is approximately 0.2m lower than that on the north, possibly due to compression into the Group 1A surface below. Below the road surface, on the

northern edge, a linear cut was recorded along the same alignment as the road (contexts 1140 & 1166). This feature was filled with stone (contexts 1141 & 1167) and possibly represents a form of land drain for the associated road surface.

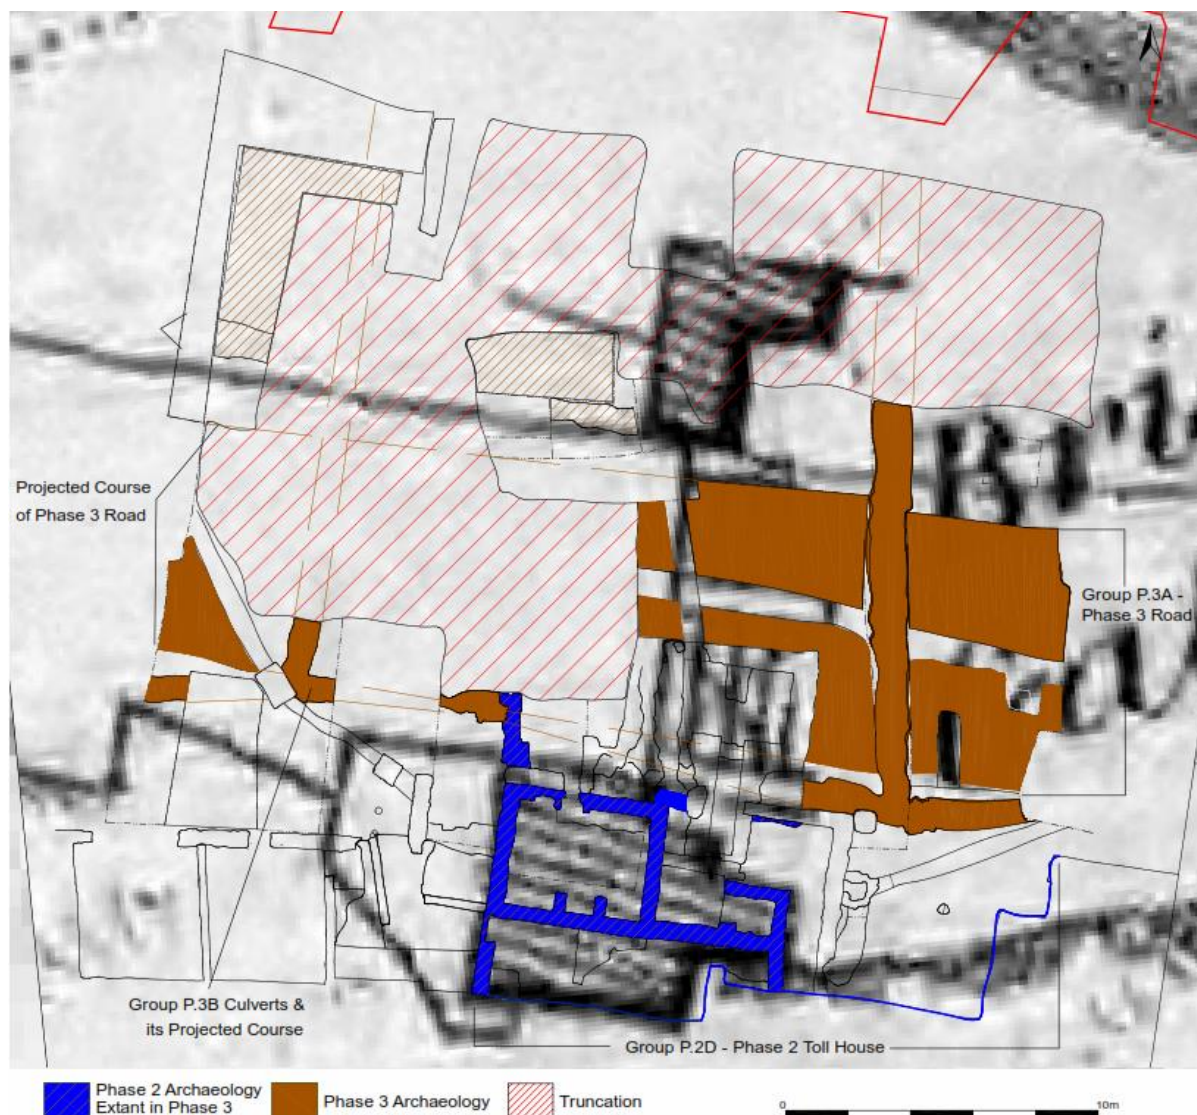
Figure 19: Plan of the site showing Phase 3, and Phase 2 features that remained extant into Phase 3. Overlain onto Plumley and Ashmead's 1828 Plan of the City of Bristol and its Suburbs.

This phase consists of features and deposits dating to c.1816. Principal amongst these are a sequence of deposits interpreted as a McAdam road surface (Group 2A). The base layer of the McAdam road (contexts 1152 & 1171) sat directly above Phase 2 road Group 2C and was composed of angular fragments of stone, with a maximum size of 60mm. The base layer was overlain by a deposit of smaller angular stones (contexts 1153 & 1172), with a maximum size of 20mm. This sequence corresponds well with the documented methods of McAdam, whereby the lower course of road should measure approximately 200mm thick and consist of stones with a maximum diameter of 75mm and the upper approximately 50mm thick with stones no larger than 20mm (Lay, 1992, 77). These deposits formed a camber on the road sloping from approximately 9.5m aOD in the road centre to 9.3m aOD on its northern and southern edges, a drop of 200mm, which is again consistent with McAdams method to lay a road 'with a gentle curve in its cross section, just sufficient to permit the water to pass from the centre towards the sides' (McAdam, 1824, 190). The width of the first McAdam road appears to be broadly the same as the Phase 2 turnpike (Group 2C), approximately 7.8m, and,

Drainage of the McAdam road also appears to have been a priority, demonstrated in the archaeology by a series of pennant sandstone culverts (Group 3B). Although large parts of this drainage system were truncated, enough remained to provide a basic layout. To the south of the road a curvilinear trunk drain running parallel with the road was recorded, which connected with north – south aligned culverts spanning the width of the road and presumably drained into the river Avon. The width between these north-south culverts was approximately 18.2m and probably continued at similar intervals off site to the east and west. To the north of the road, a small section of culvert which ran east to west before turning to northwards, presumably again draining into the river, was also recorded.

The northern culvert appears to have been truncated (context [1176]) at about the same time as a resurfacing and widening of the first McAdam road occurred (Group 3C). Overlying the robbed culvert was a levelling deposit (context 1178), which was overlain by a dump of compacted angular stone (context 1179) with a maximum size of 70mm, which was sealed by the road surface (context 1180) composed of a dump of angular stone with a maximum size of 20mm. The widening appears to have added a further 1.4m to the road width (total of 9.1m). Although no finds were recovered from deposits or features associated with this widening and resurfacing, the construction methods are almost exactly the same as those recorded in the first McAdam surface (Group 3A).
